An ASAE Meeting Presentation

Paper Number: MC04-307

Subsurface Drip Irrigation (SDI) System Remediation - A Case Study

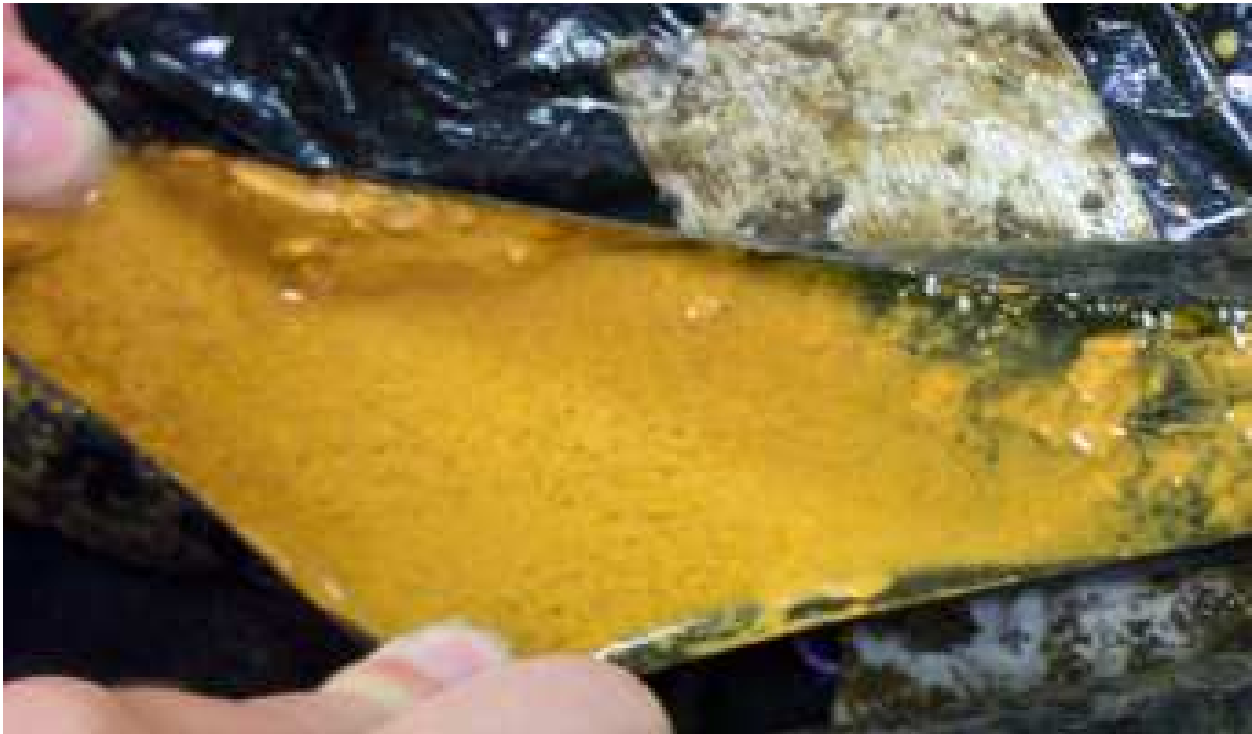
During the winter and early spring of 2002/2003, the producers made contact with K-State Research and Extension personnel. Up until this time, the only operational and maintenance recommendations produced by the designer/installer had been to periodically flush the system. During the initial telephone contacts, verbal generalized information on dripline maintenance procedures, including flushing, chlorination and acidification was provided. SDI bulletins were mailed to the producer. The producer also agreed to have a water quality analysis completed and also removed sample sections of dripline from the visually stressed and non-stressed portions of the field. A cut-away section of the dripline is shown in Figure 2; an orange/yellow paste essentially coated the inner walls of the dripline. The material had slugged off during the handling of the dripline.

Figure 2: Cut-away of case study field dripline showing precipitant accumulation.

An analysis of the precipitant clogging the dripline confirmed it was primarily calcium bicarbonate, colored by the associated iron. The sample length of dripline was tested for flow and found to be almost entirely clogged. The producer indicated he had access to a economically priced sulfuric acid source, however muratic acid was successfully used in the lab test to see if remediation was possible. Sulfuric acid is highly corrosive and may not be the safest and best acid for farmstead use.

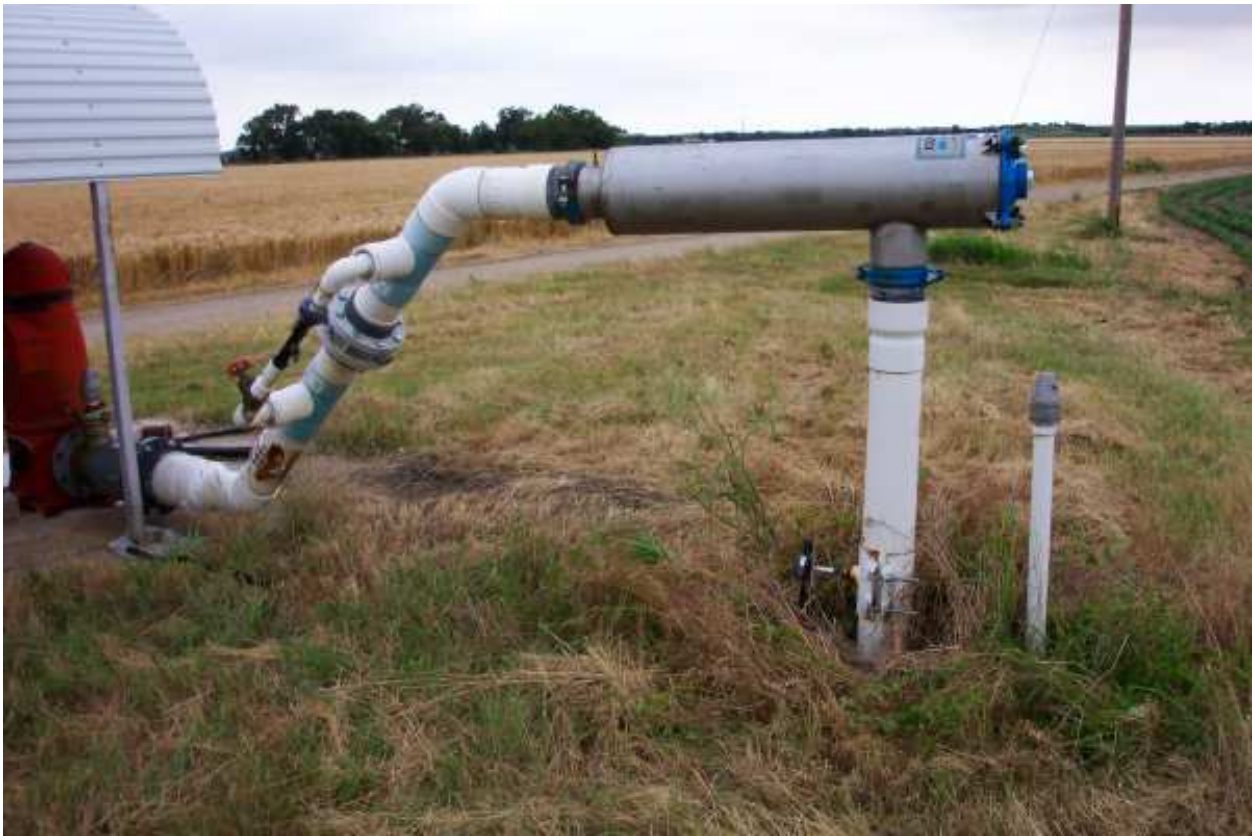
A site inspection was conducted in the early summer of 2003. At this time, the existing soybean crop was also showing water stress in the upper one-third of the field. The system design failed to meet many of the minimum SDI design recommendations that were discussed previously. It was recommended that improvements be made. A new contractor reconstructed the filtration, injection and control valves at the pumping station. The irrigation zone (the field is irrigated as one unit) was also split into two flushing zones. This would allow for higher water flow velocities in the driplines during flushing. Improvements also included addition of air relief vents on the high points of the system, piping and valves to allow direct water bypass from the well, should well treatment be required, and improved placement of the flow meter (Figure 3a and 3b).

Figure 3a: Original pumping plant and filtration configuration of the case study SDI system.

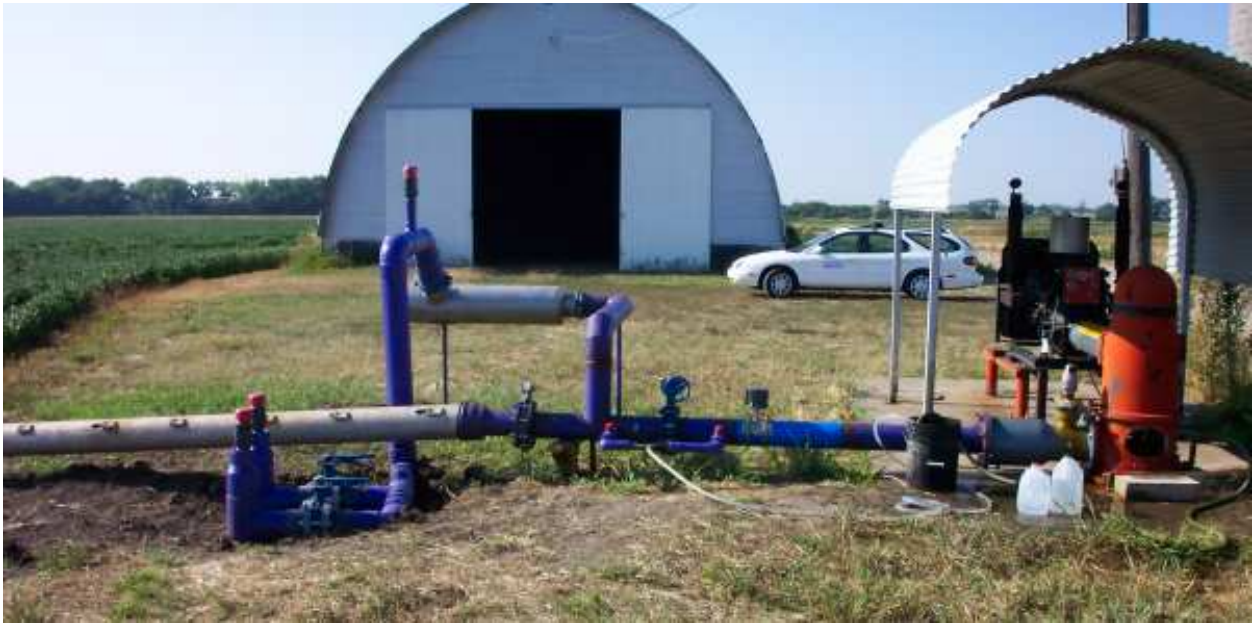
Figure 3b. Improved pumping plant and filtration configuration of the case study SDI system.
